# **EXHIBIT 3**

## **(Part 2 of 2)**

*M.Delvin & Associates, Inc. Project No. 2009.01  
Diamante, Cabo San Lucas*

*Project Review and Site Visit Report  
November 2015*

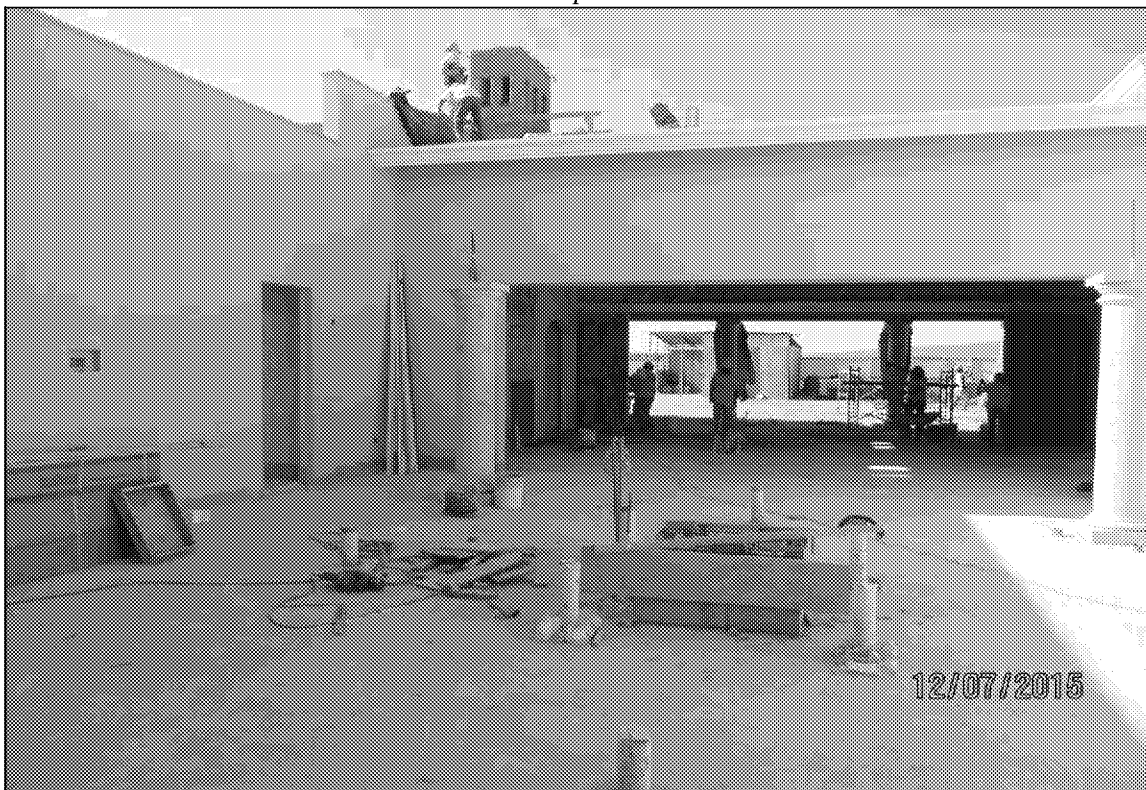
**Photograph 26:** GV 15: Exterior finishes of the courtyard including stone columns are being placed.

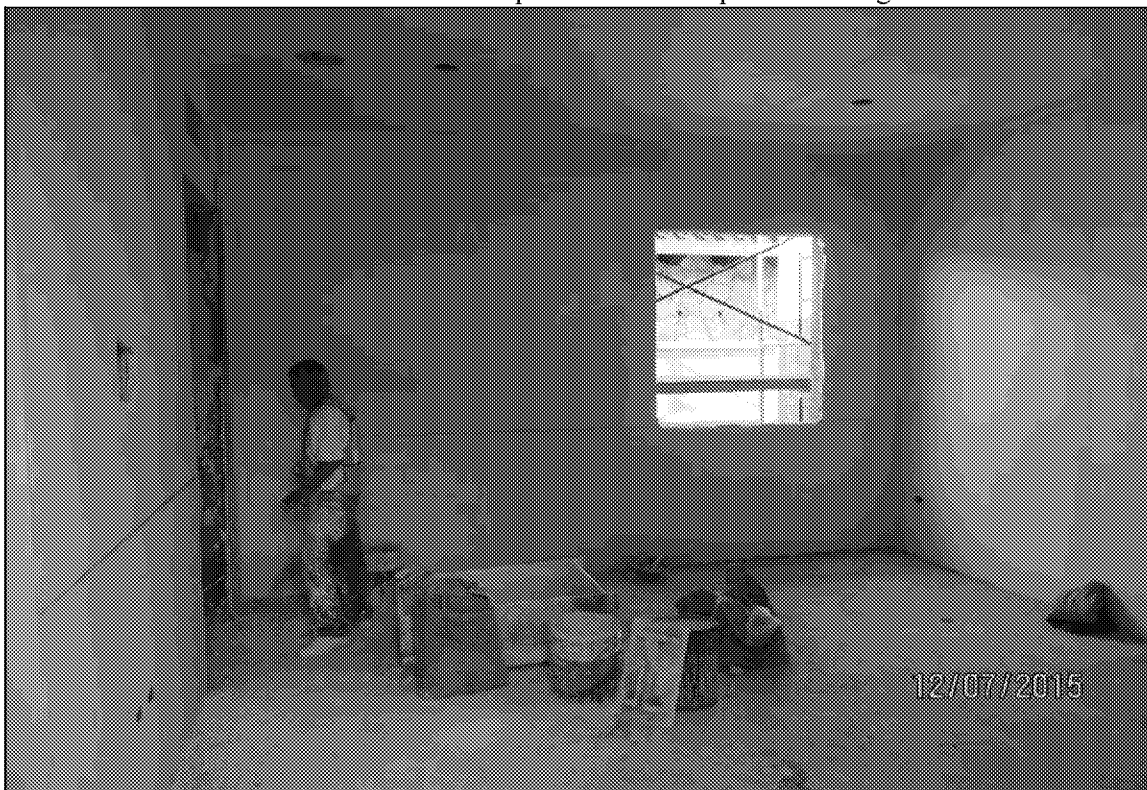
**Photograph 34:** GV 26: Interior lime-cement plaster coating is being placed.

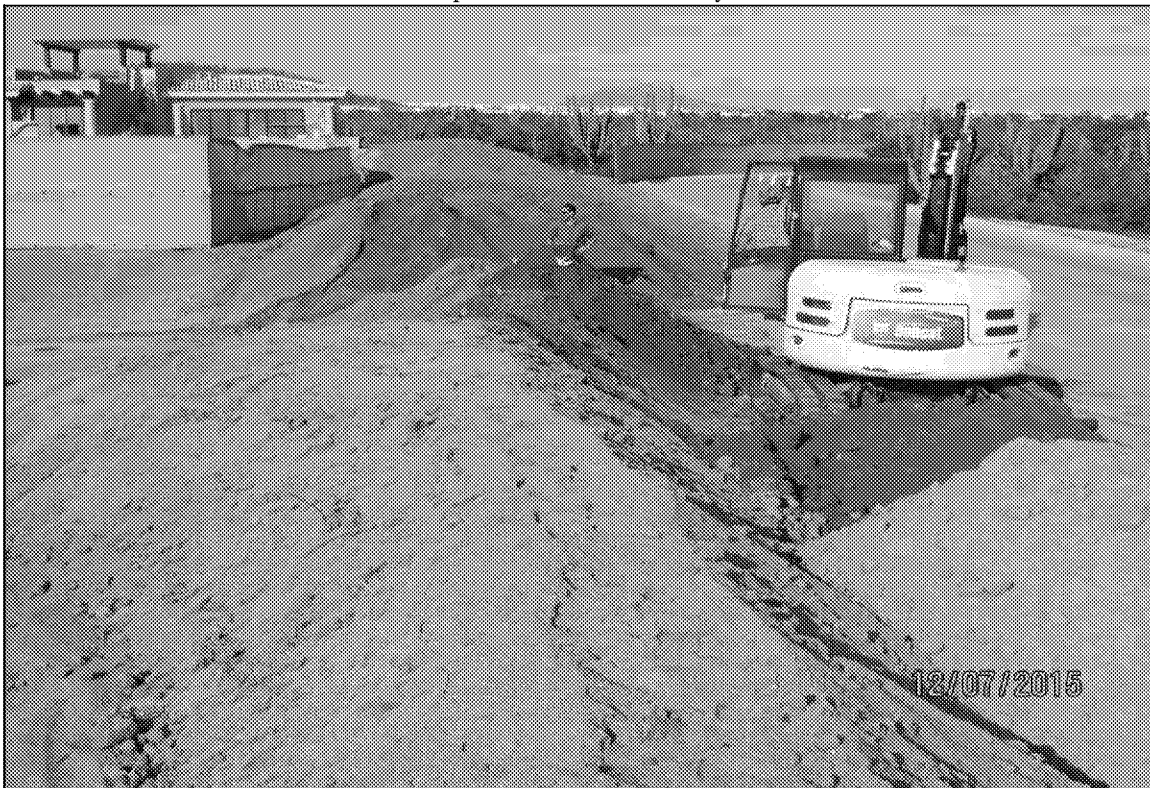
**Photograph 56:** Casitas Site: The berm along Diamante Blvd. is being constructed to provide a vegetation site and sound barrier along the Casitas site.

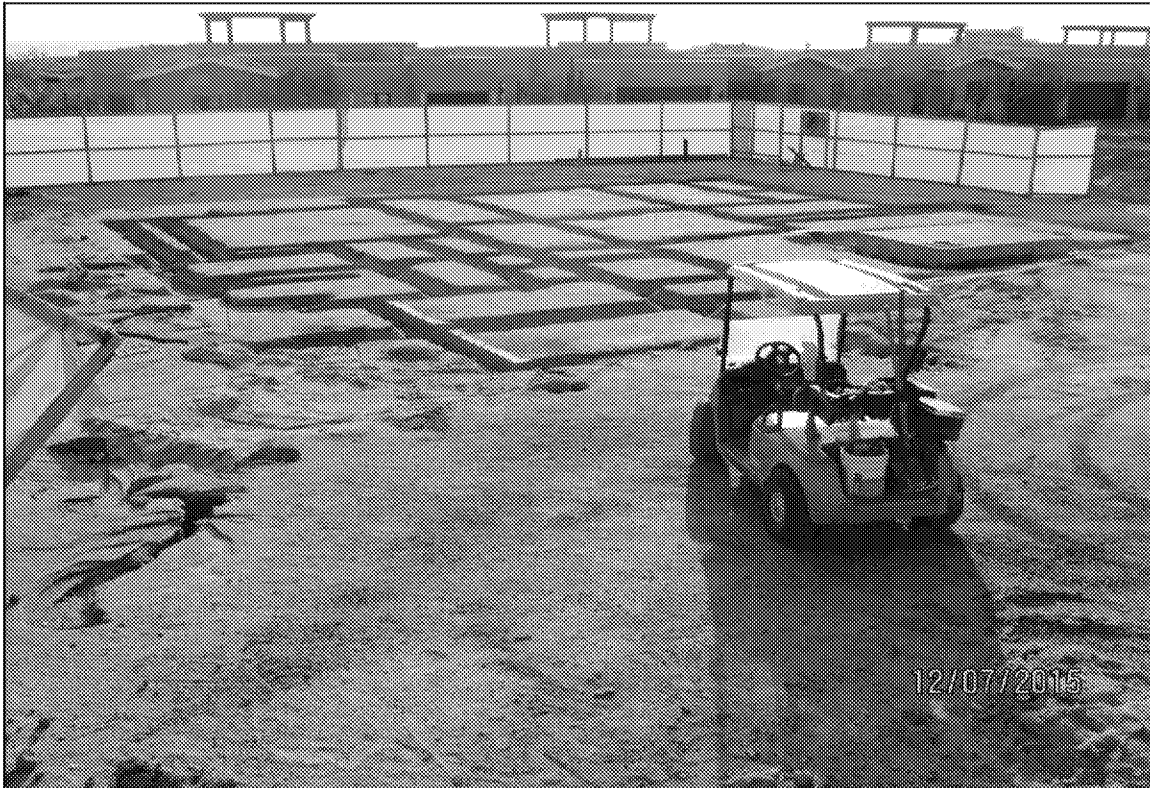
**Photograph 61:** Casitas Home Lot 8: No additional work was done on this home in November.

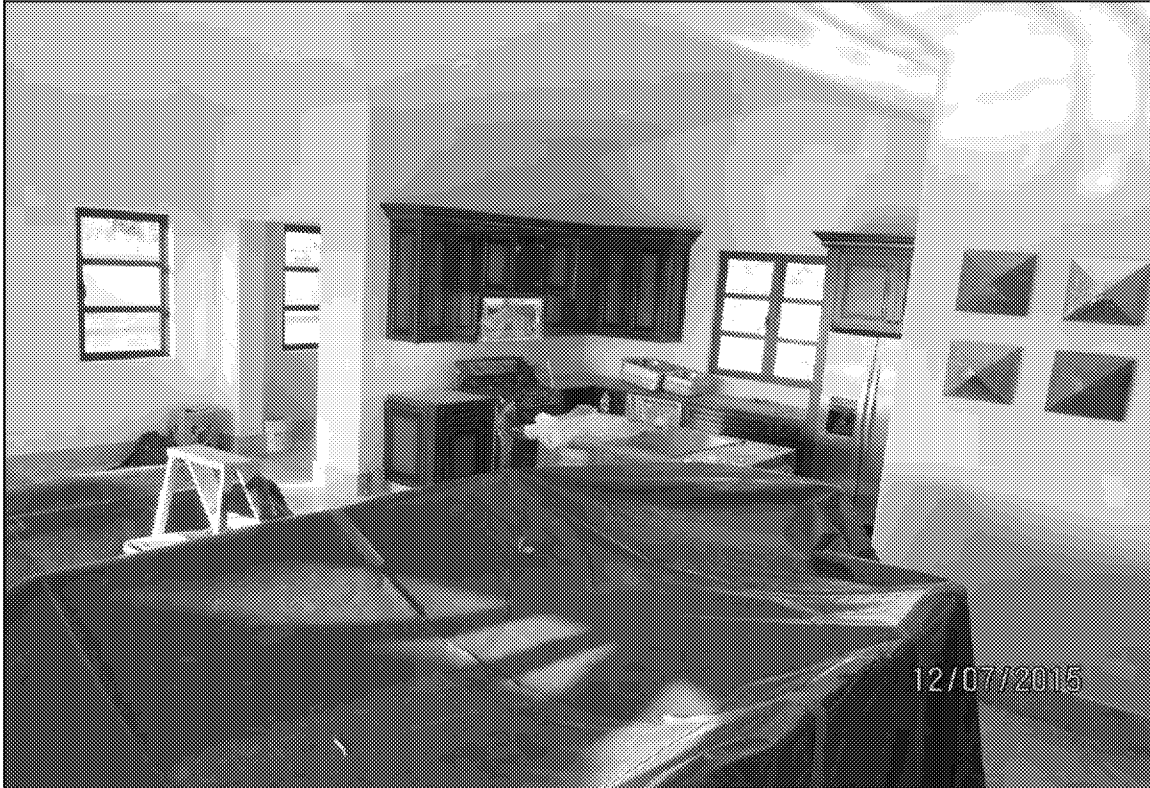
**Photograph 67:** Casitas 20: The cabinets have been installed and furniture is being moved in.

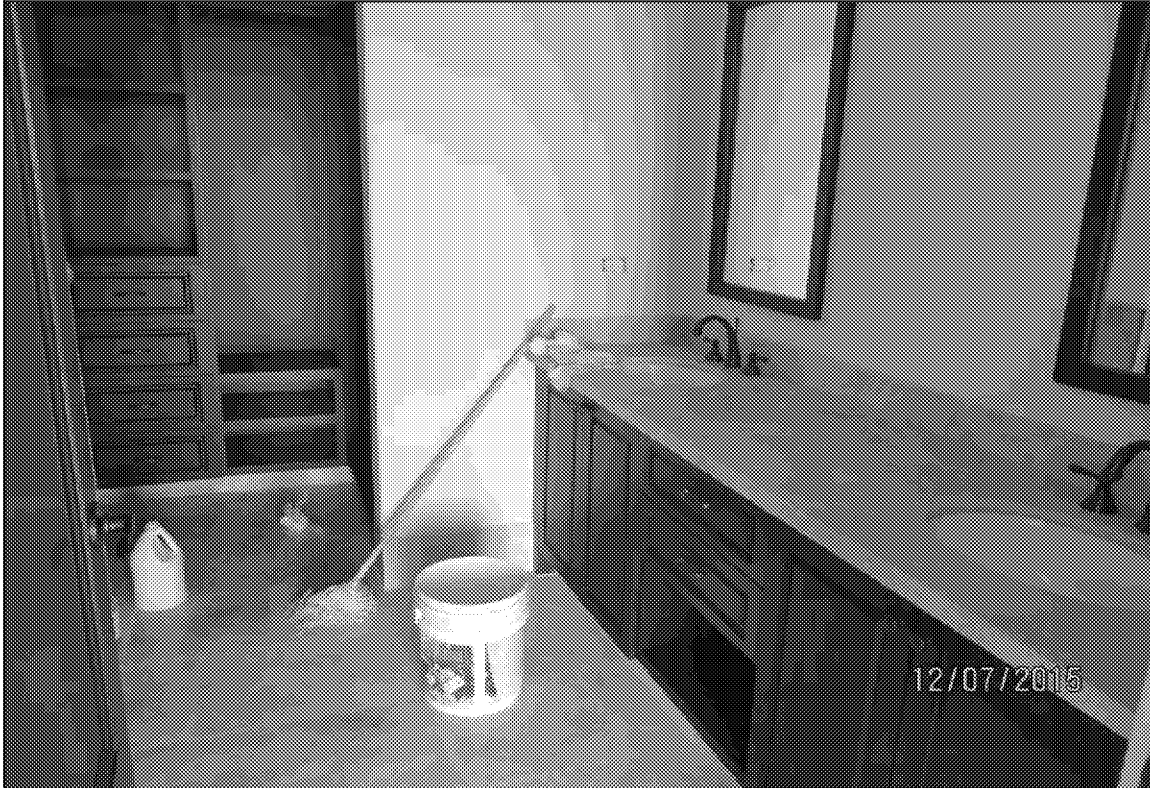
**Photograph 71:** Casitas 21: Bathroom vanity, countertops, sinks and fixtures have been installed and closet shelving has been installed.

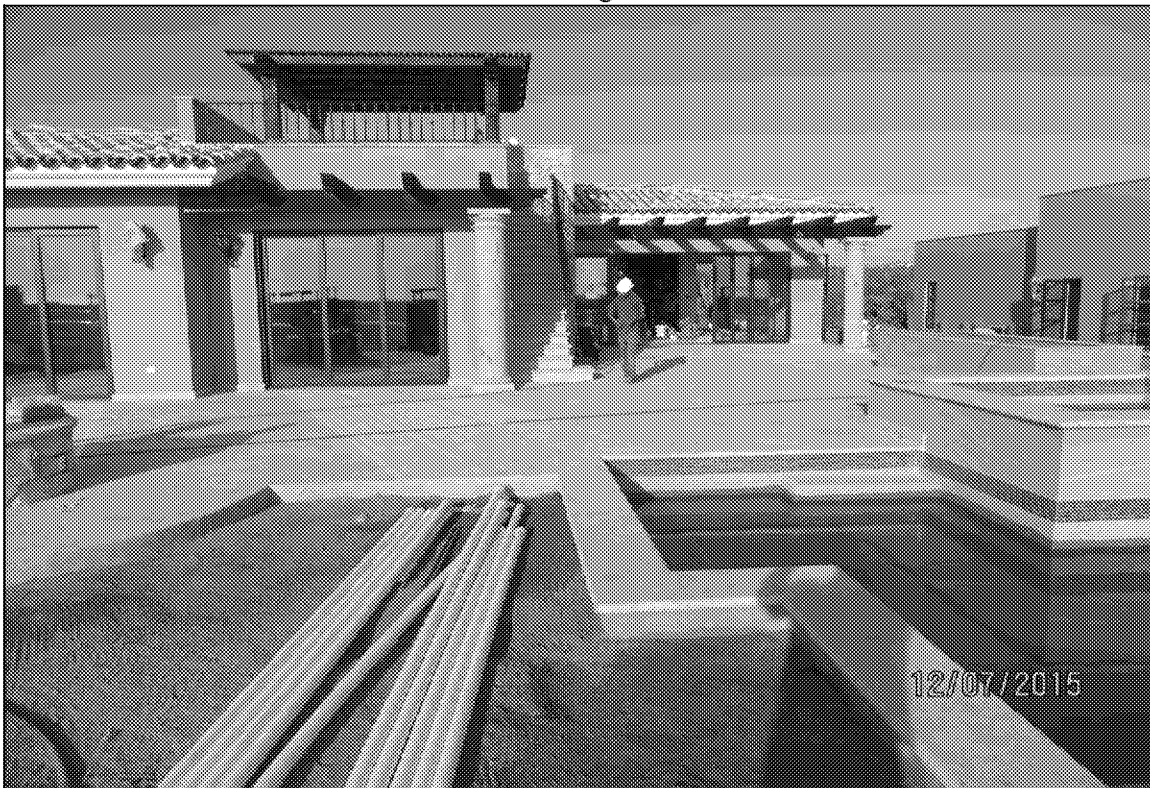
**Photograph 72:** Casitas 21: The pool has been constructed and is filled with water. The patio is completed, including the stone finishes.

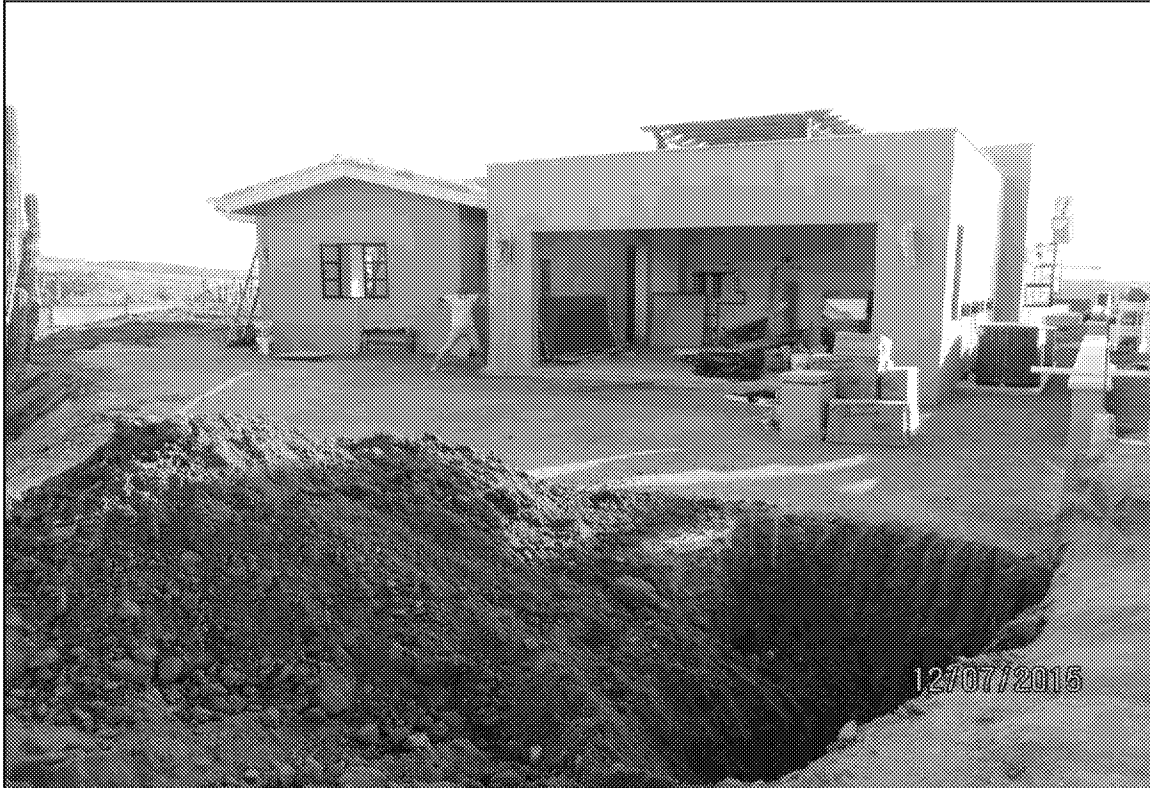
**Photograph 73:** Casitas 22: The exterior finishes are generally complete. The excavation in front of this home is for utility line hookup.

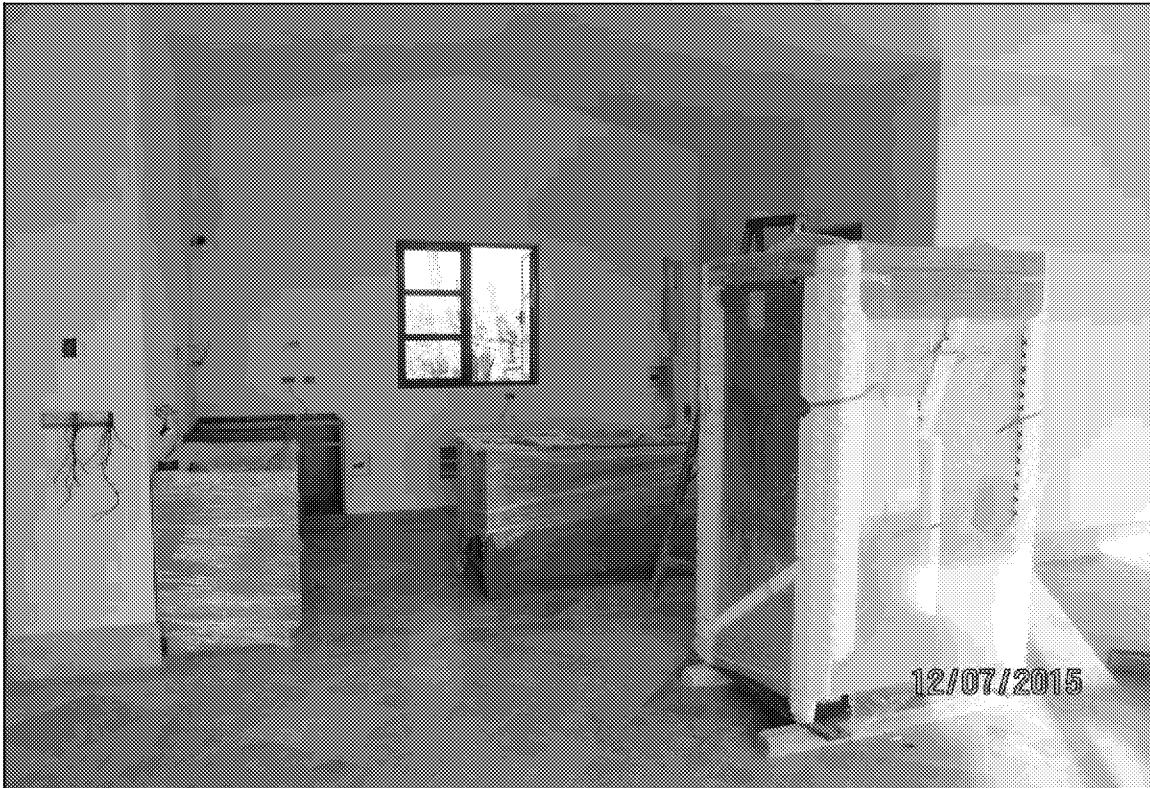
**Photograph 74:** Casitas 22: Cabinet installation is underway.

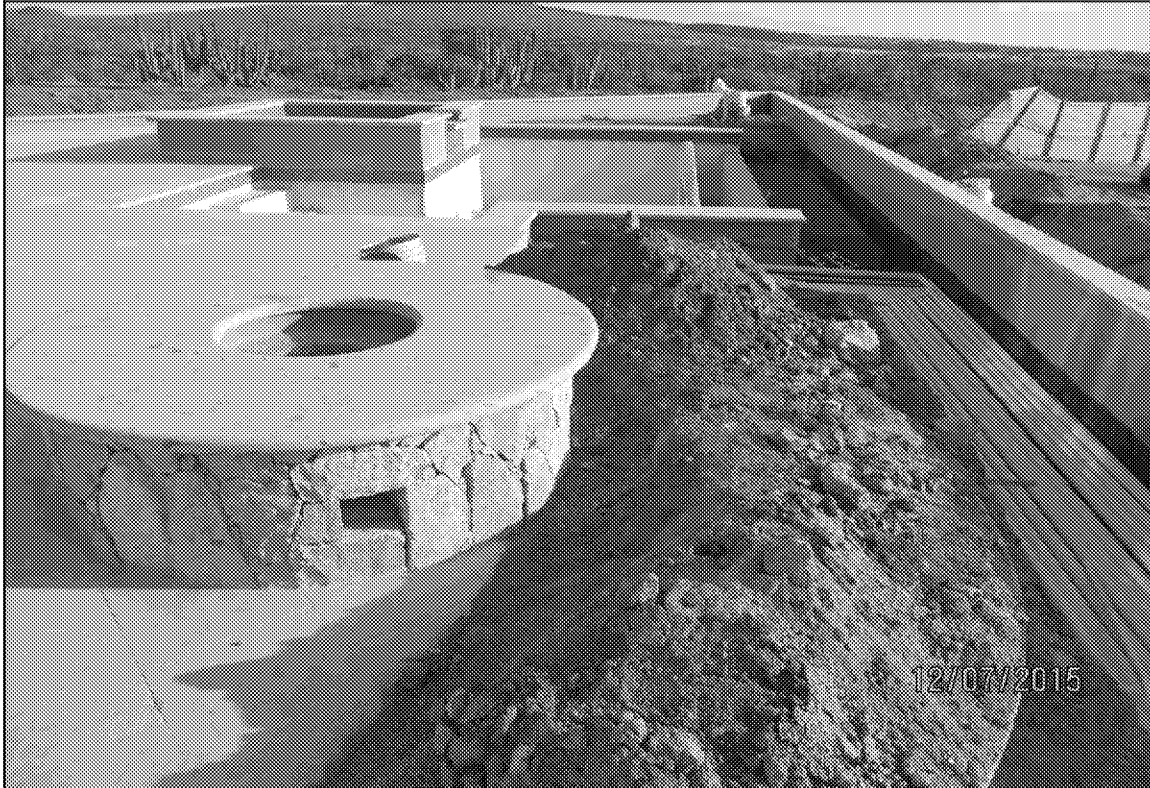
**Photograph 75:** Casitas 22: The patio slab and stone finishes and the pool structure and finishes are complete and plumbing lines for the pool equipment are being installed.

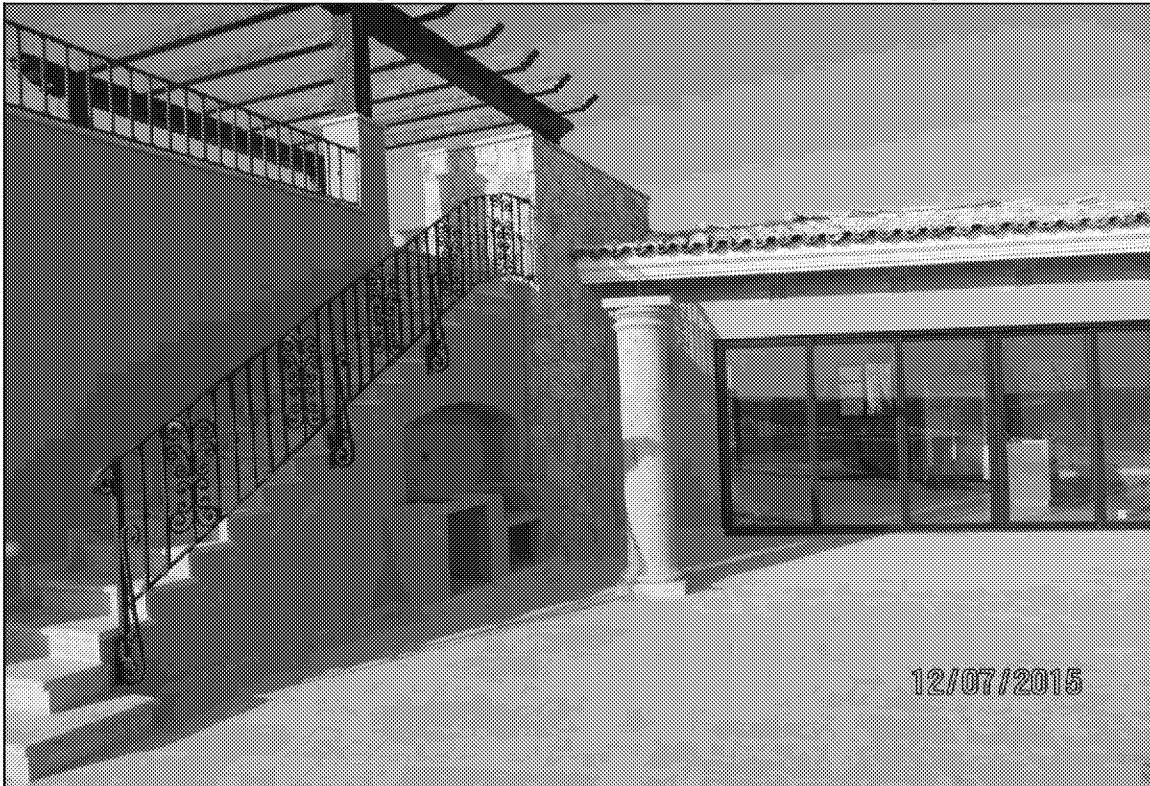
**Photograph 76:** Casitas 22: The exterior finishes including the second floor trellis beams are complete. The outdoor grille and cooking area has not yet been placed.

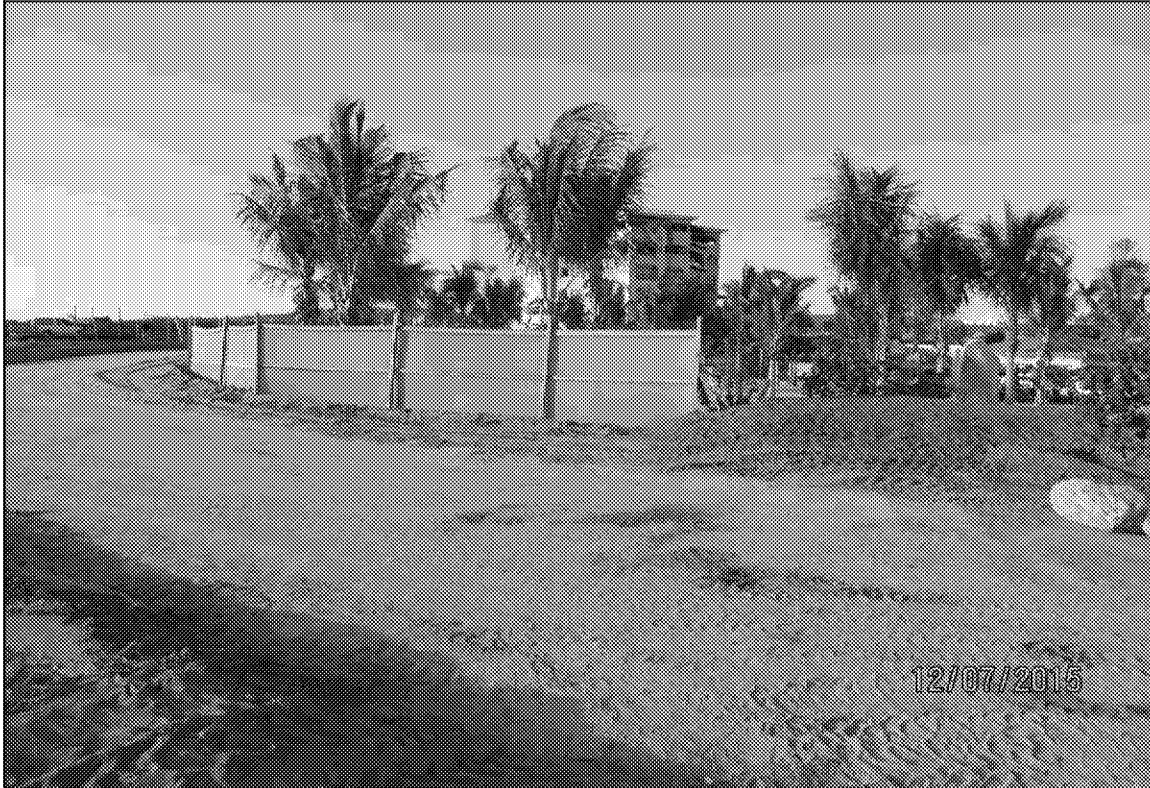
**Photograph 79:** Resort Site Work: The cart path leading to Bungalow 7 and 8 from the Resort Tower 2 area has been constructed and is topped with crushed stone. This will remain unpaved for the near future.

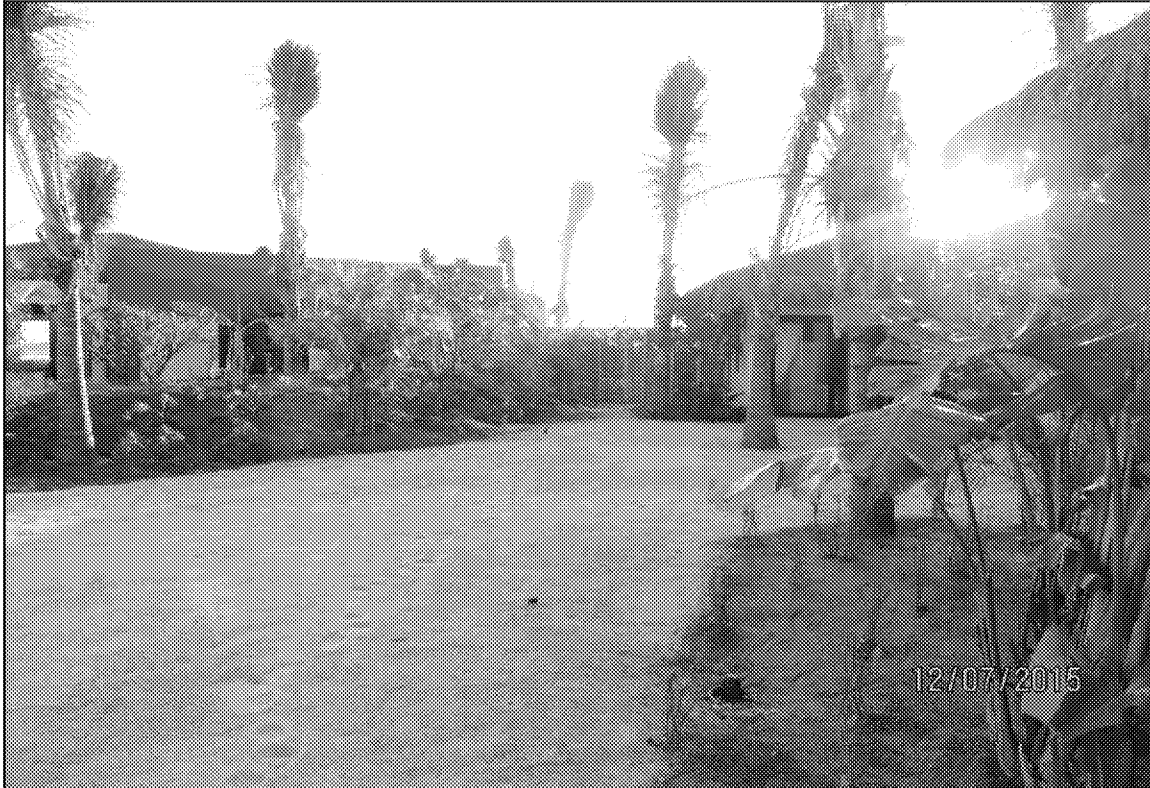
**Photograph 81:** Resort Site Work: The site around Bungalow 7 and 8 has been completed with vegetation.

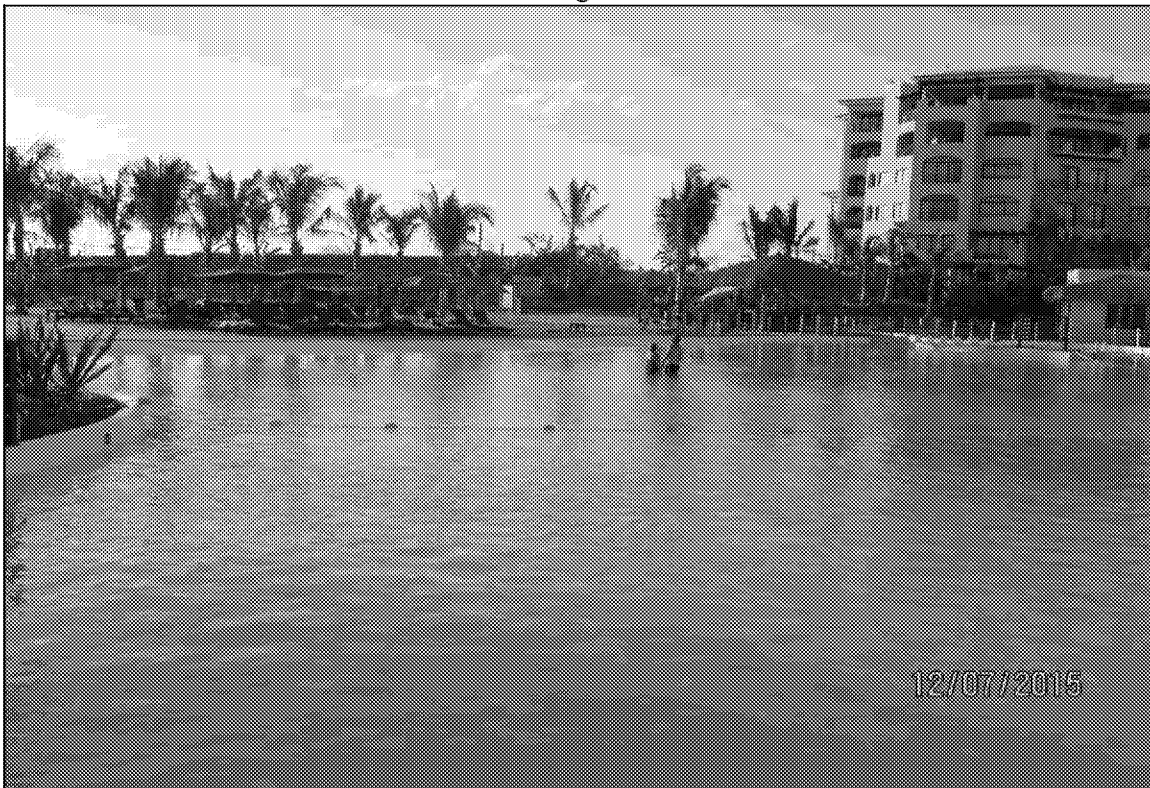
**Photograph 82:** Resort Lagoon Beach H: The new beach is being fully utilized as an activities beach.

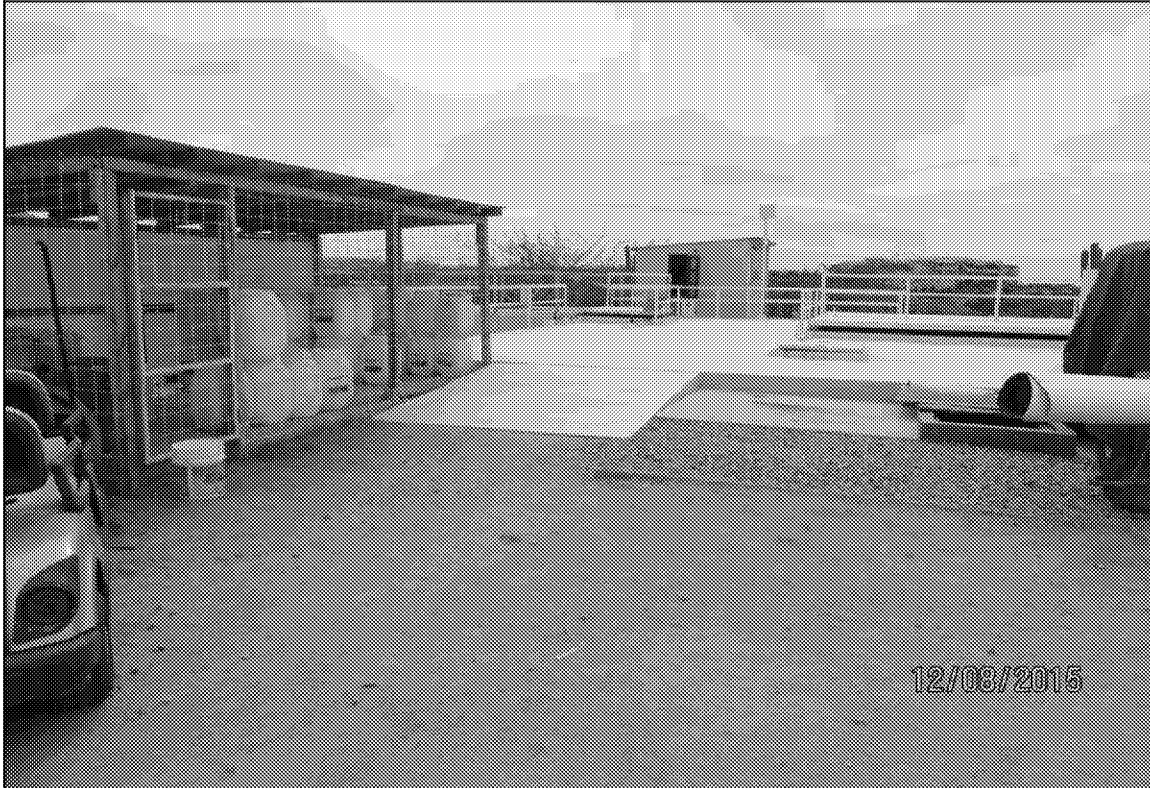
**Photograph 83:** Resort Lagoon Pump and Filter structure: Improvements made to the service area include new enclosures for chlorine storage.

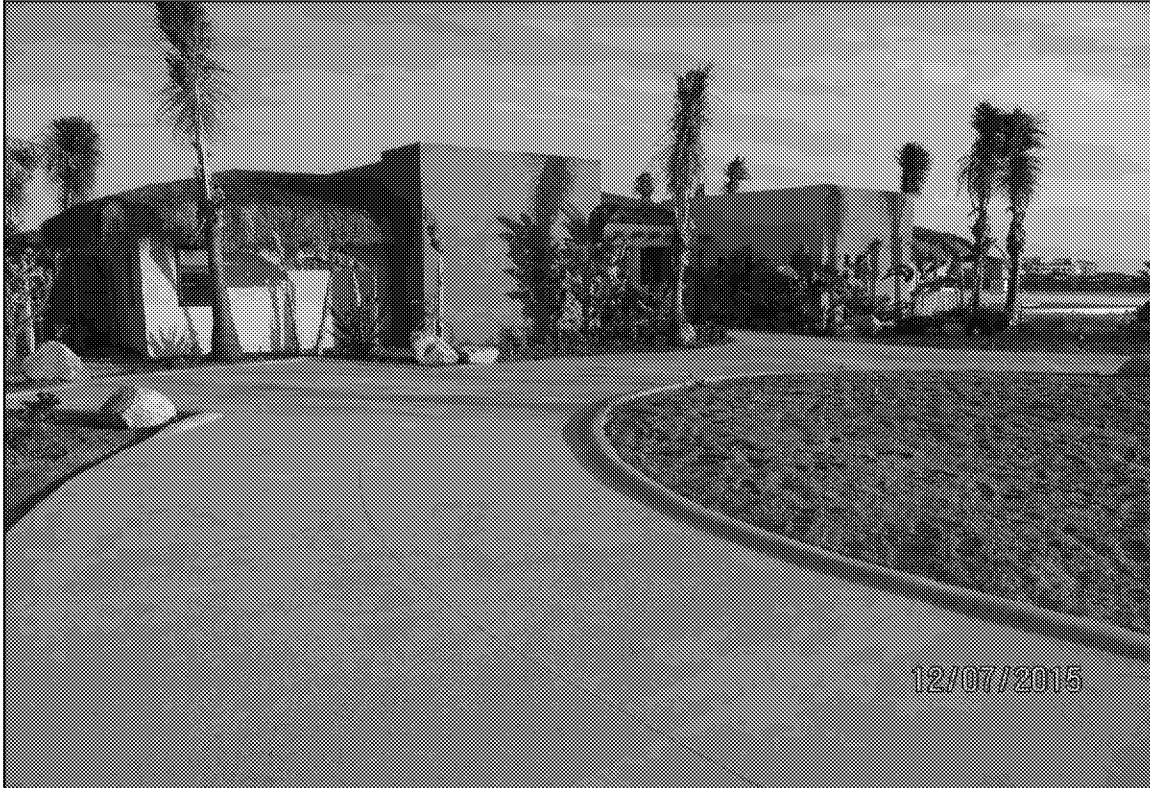
**Photograph 85:** Resort Bungalow 7: The front entry is completed with paved cart path and landscaping. The building exterior finishes are complete.

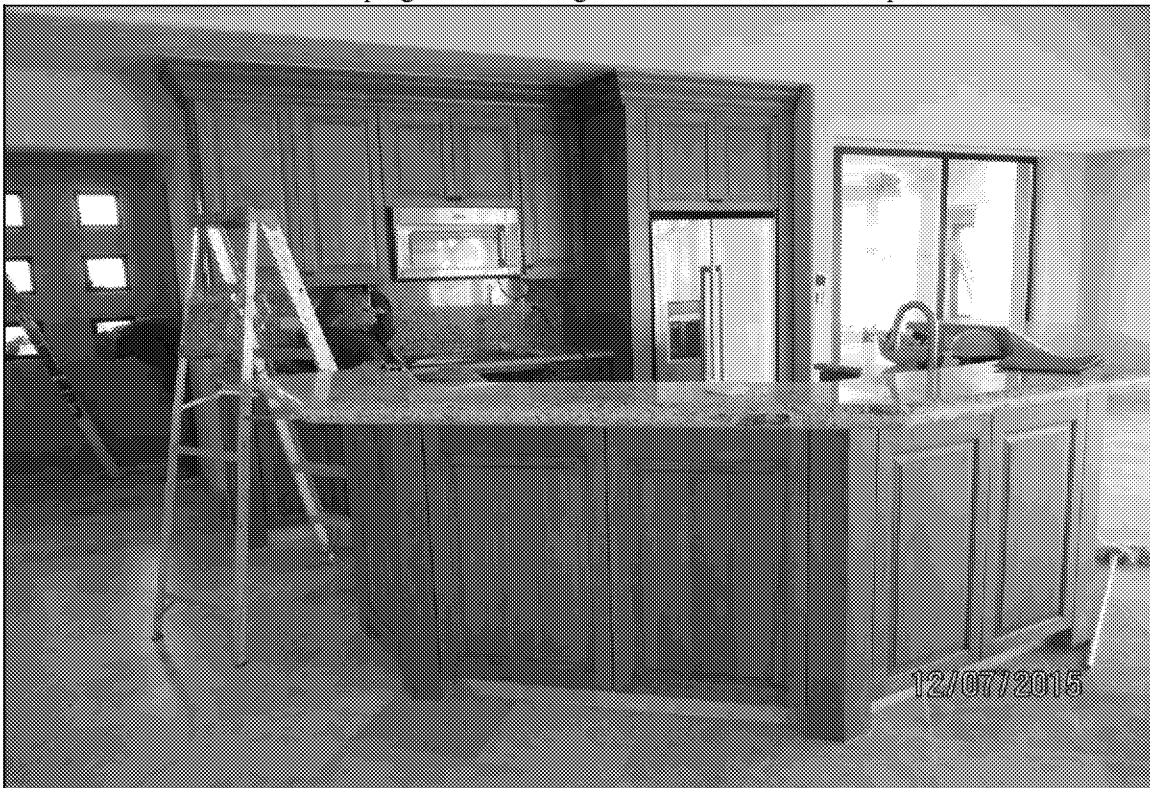
**Photograph 86:** Resort Bungalow 7: Interior finishes are complete and carpentry including cabinets is complete. The kitchen appliances have been installed.

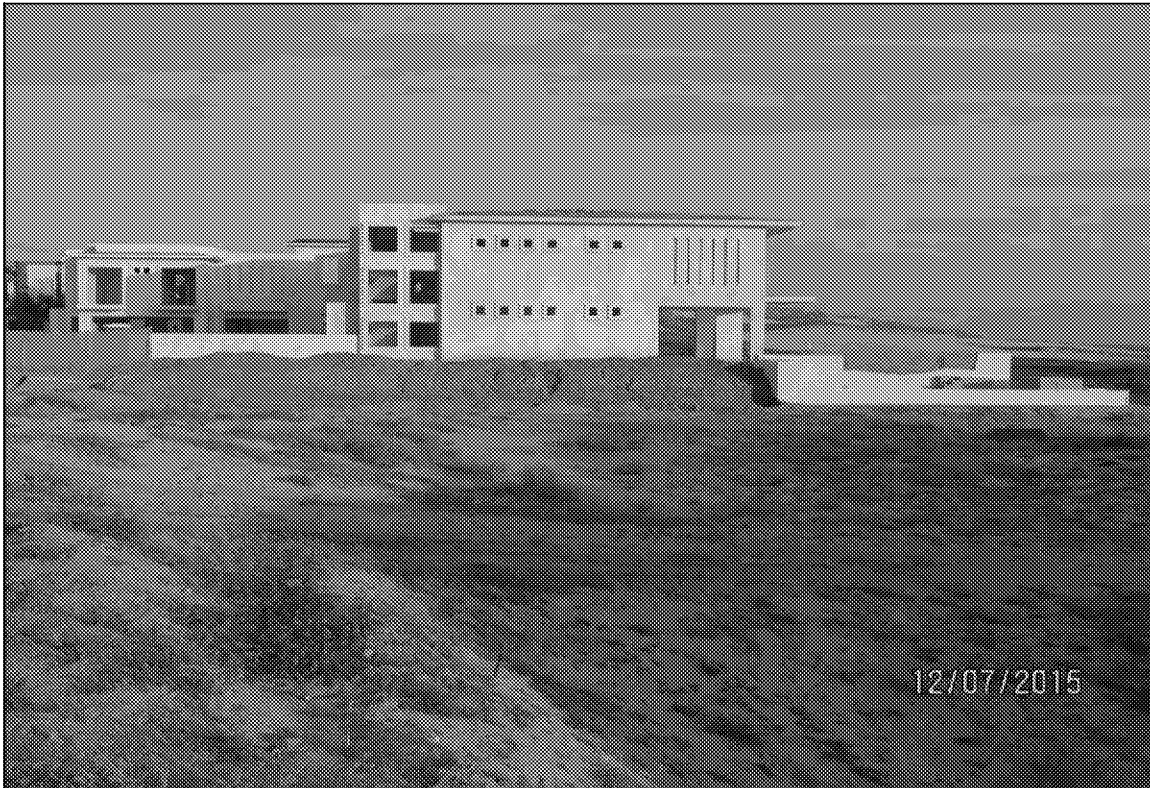
**Photograph 100:** Beach Estate 37: This private home by a private contractor has not made progress over the past several months, but construction is expected to resume in December.
